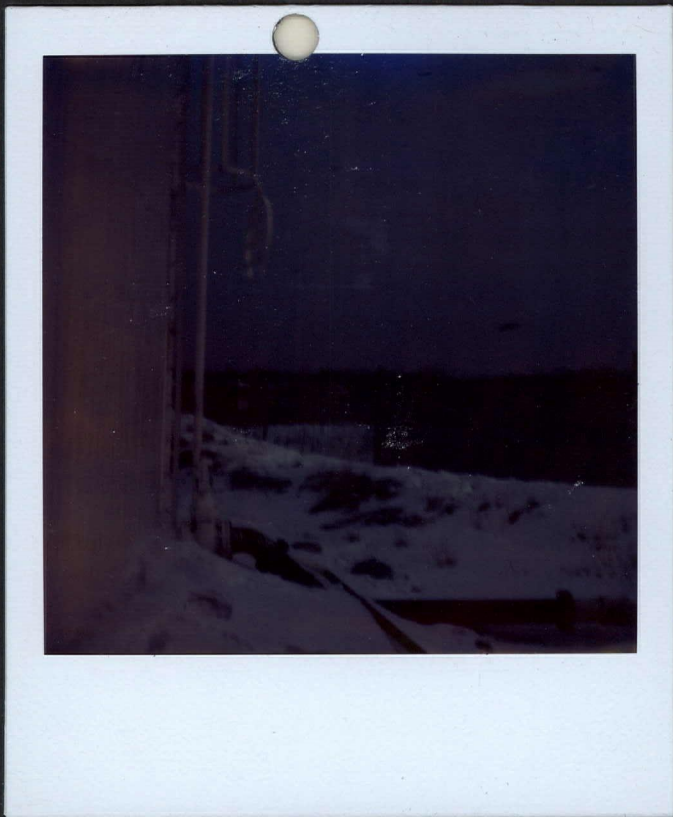
"Earthen berm" from inside the dike. Approx. 3'.

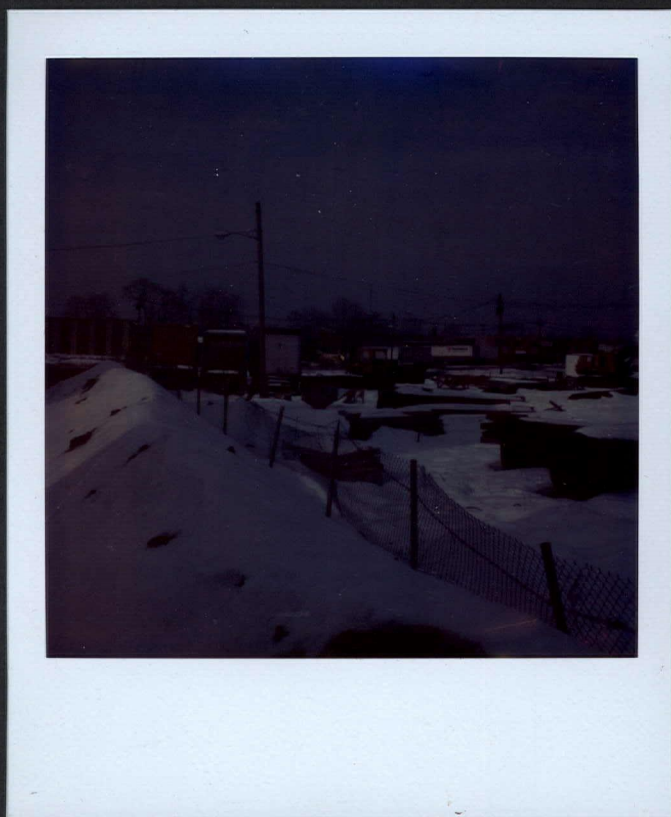
Security fence in the south-east corner of the dike.

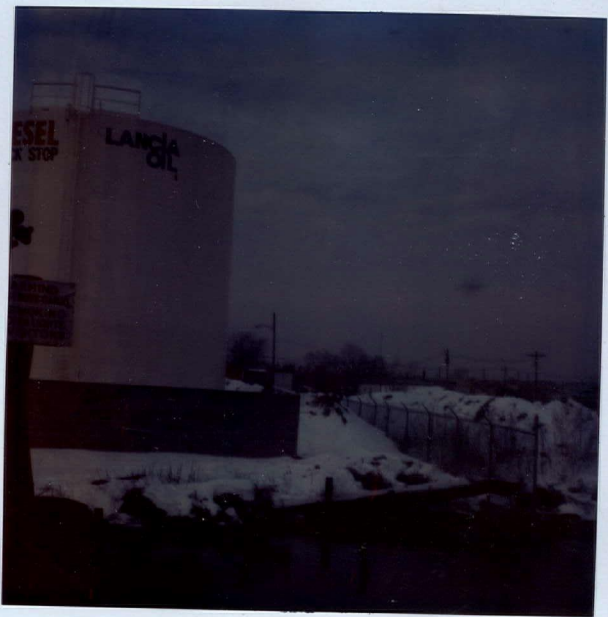
①

Unfinished dike with "earthen berm". Hackensack River in the foreground.

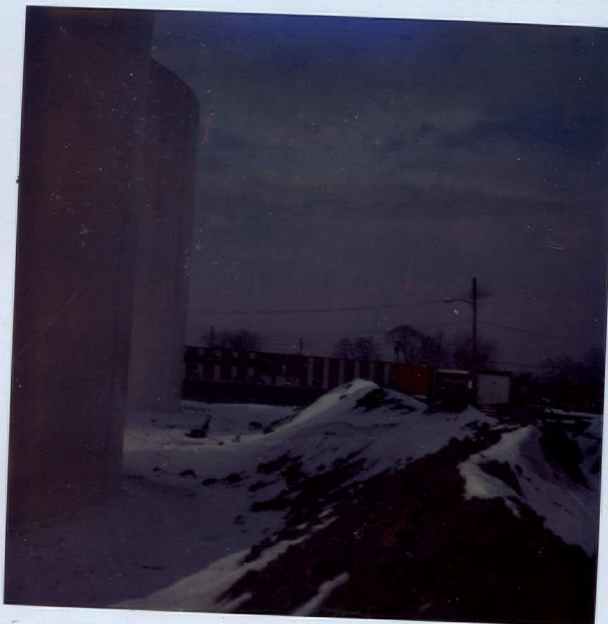
②

"Earthen berm" composed of broken asphalt, brick, wood and soil. Approx. 7'.
